UNDERWATER BRIDGE INSPECTION REPORT

STRUCTURE NO. 23503

ROOT RIVER

DISTRICT 6 - FILLMORE COUNTY

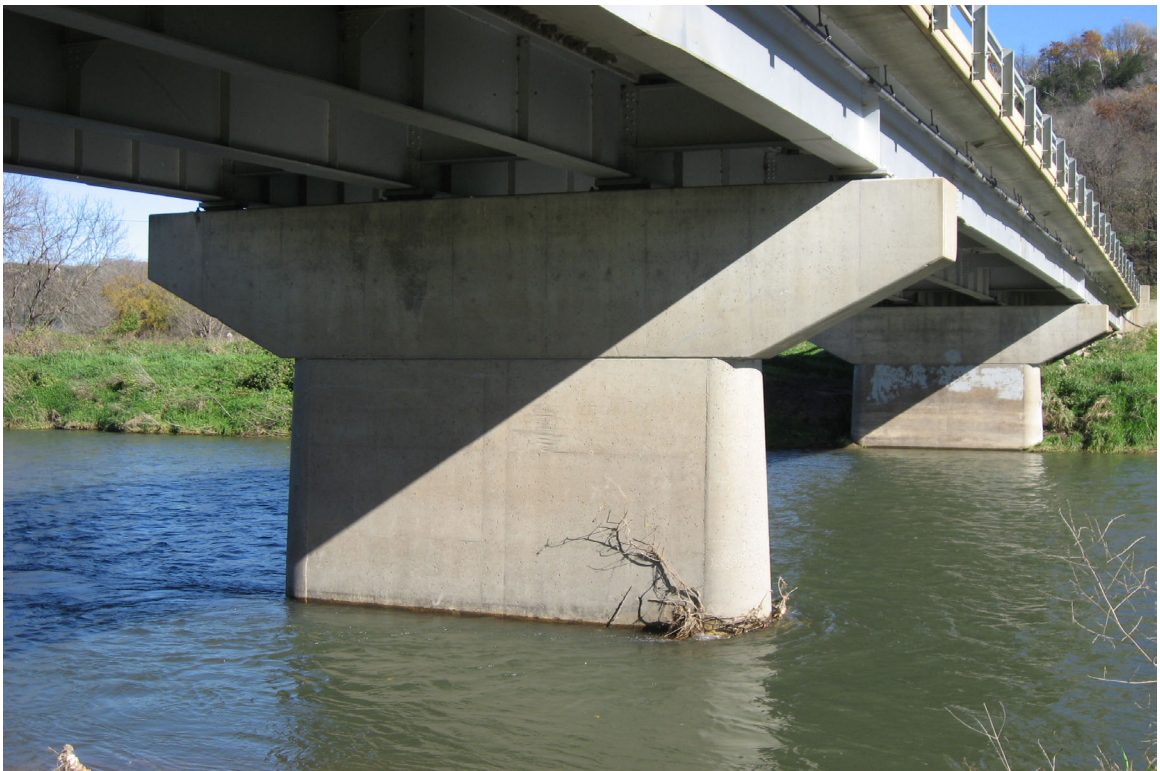
Photograph 2. View of Pier 2, Looking Northeast.

- (A) The submerged concrete of Pier 2 was in good and sound condition with only random light scaling observed from the top of the footing to 1 foot above the waterline.
- (B) Two impact related voids were also observed on the upstream nose of Pier 2 above the waterline, 2 feet long by 1 foot wide by ½ inch maximum penetration.
- (C) The footing of Pier 2 was exposed along the entire perimeter with a maximum vertical exposure of 4 feet at the midpoint of the upstream end with a 1 foot long section with undermining ½ inch high by 3 inches deep.
- (D) A light accumulation of timber debris was observed hanging at the waterline at the upstream nose of Pier 2. Also, a moderate accumulation of debris was observed on the scour depression from the channel bottom up 3 feet.
- (D) A scour depression was observed at the upstream end of Pier 2 with a radius of 3 feet and a depth of 3 feet.

- 5 The concrete of both piers was smooth and in good condition.
- 6 A 3-foot-radius, 3-foot-deep scour depression was observed at the upstream end of Pier 2.

- 9 The footing was exposed along the entire perimeter of Pier 2 with a maximum vertical exposure of 4 feet at the midpoint of the upstream end with a 1 foot long section with undermining 1/4 inch high and 3 inch maximum penetration. Vertical exposure at the southwest corner was 2.5 feet, at southeast corner was 3 feet, along east face was 2.5 feet, and at the downstream end was 6 inches.

- (A) Monitor the scour depression and footing exposure at Pier 2 during future inspections. If these conditions progress, repairs can be considered including filling the scour hole at the upstream end of Pier 2 by designing and placing properly sized riprap.
- (B) Reinspect the submerged substructure units at the normal maximum recommended (NBIS) interval of five (5) years.

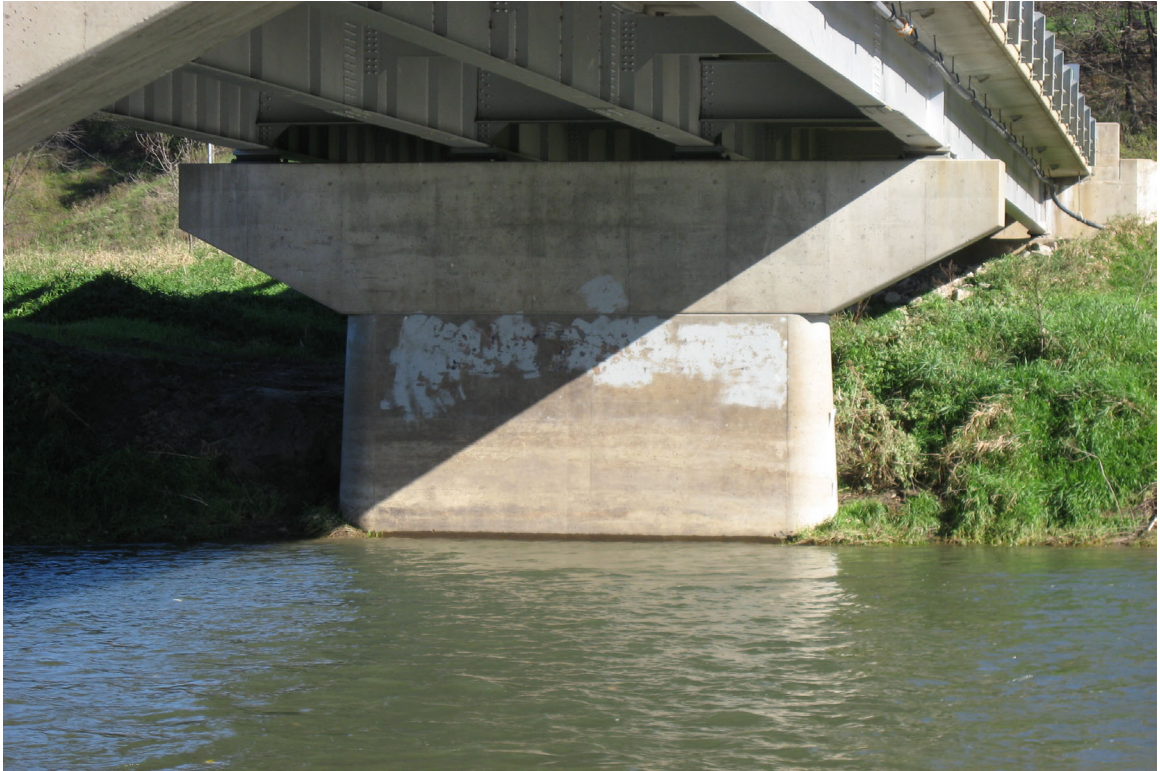
Photograph 3. View of Pier 3, Looking Northeast.

- 4 Light scaling of concrete was observed from the top of the footing (or from channel bottom at Pier 3) to 1 foot above the waterline, 1/4 inch maximum penetration.

- 10 The channel bottom at Pier 3 consisted of sandy silt with a maximum probe rod penetration of 6 inches.

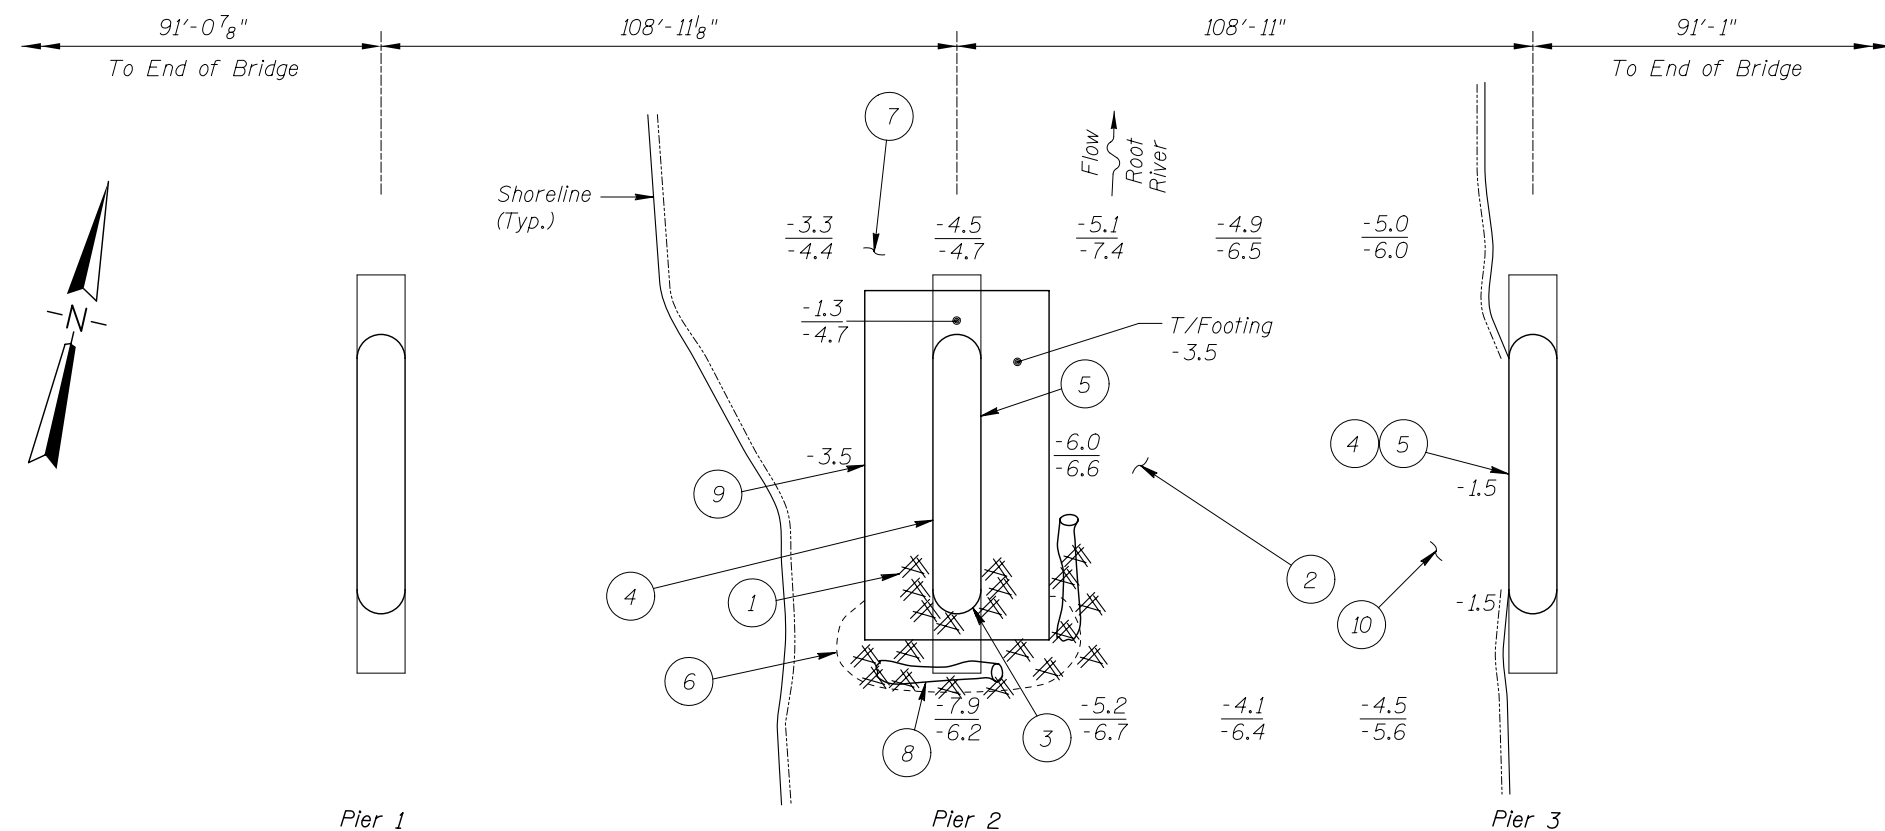
INSPECTION AND SOUNDING PLAN

- 1 A light accumulation of timber debris consisting of 2 inch diameter and smaller branches was observed at the upstream nose of Pier 2 at waterline.
- 2 The channel bottom material consisted of fine sandy gravel with 2 inches of maximum probe rod penetration.

- 3 Two horizontal impact related voids were observed on the upstream nose of Pier 2 above the waterline, 2-foot-long by 1-inch-wide with 1/2 inch of penetration and exposed aggregate.

- 7 The channel bottom at the downstream end of Pier 2 consisted of sandy infilling with 3 inch probe rod penetration.
- 8 A moderate accumulation of timber debris, up to 1.5 feet diameter, was observed within the scour depression at the upstream end and along the east face of the pier, extending from channel bottom up 3 feet.
